WHISTLE DETAILS

B & O P-7*5300 1"

I.D. ALKIRE 1965

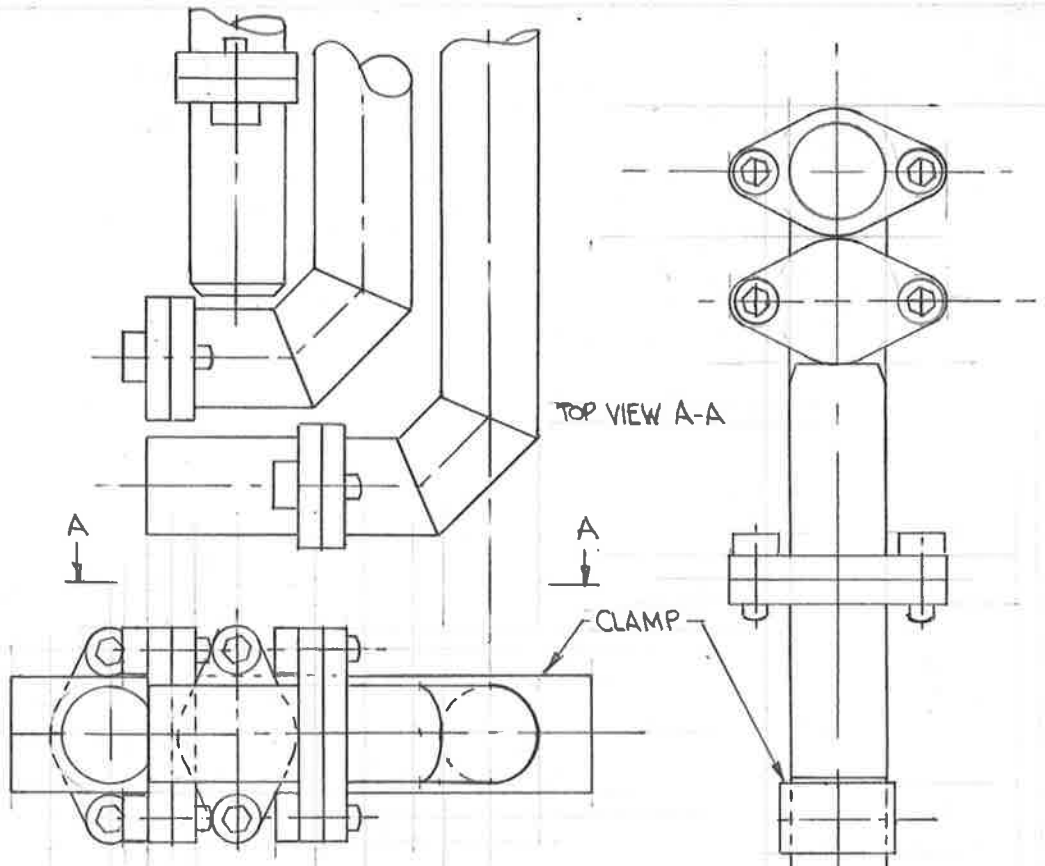
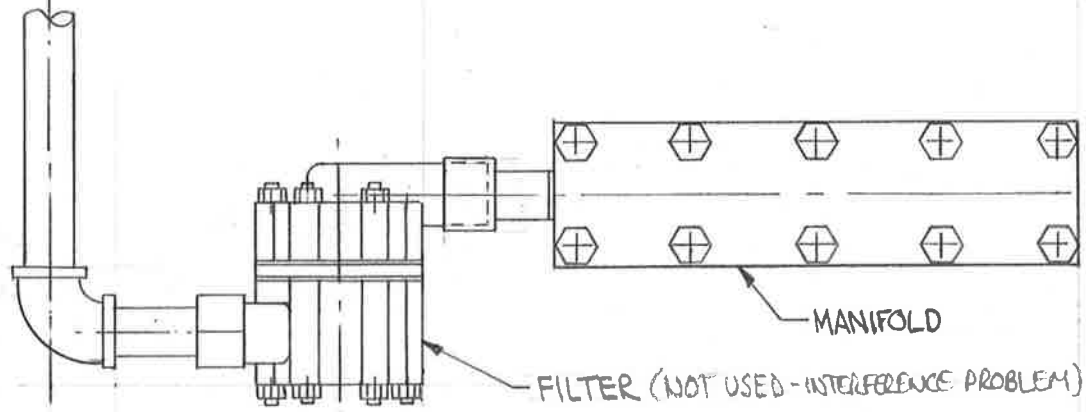
TOP VIEW A-A

CLAMP

RIGHT HAND VIEW LOOKING INBOARD
DRAINAGE SLOPE NOT SHOWN

VIEW LOOKING FORWARD
DRAINAGE SLOPE NOT SHOWN

TO WHISTLE VALVE

MANIFOLD

FILTER (NOT USED - INTERFERENCE PROBLEM)

LEFT HAND VIEW LOOKING INBOARD
DRAINAGE SLOPE NOT SHOWN
